TITAN ENGINEERING CONSULTANTS, LLC

DATE: September 26, 2019

RE: Engineer's Completion Certification of Foundation Repairs
@ 9615 FM 621--Staples, Texas
Ref.A) Centex proposal dated 07/24/19

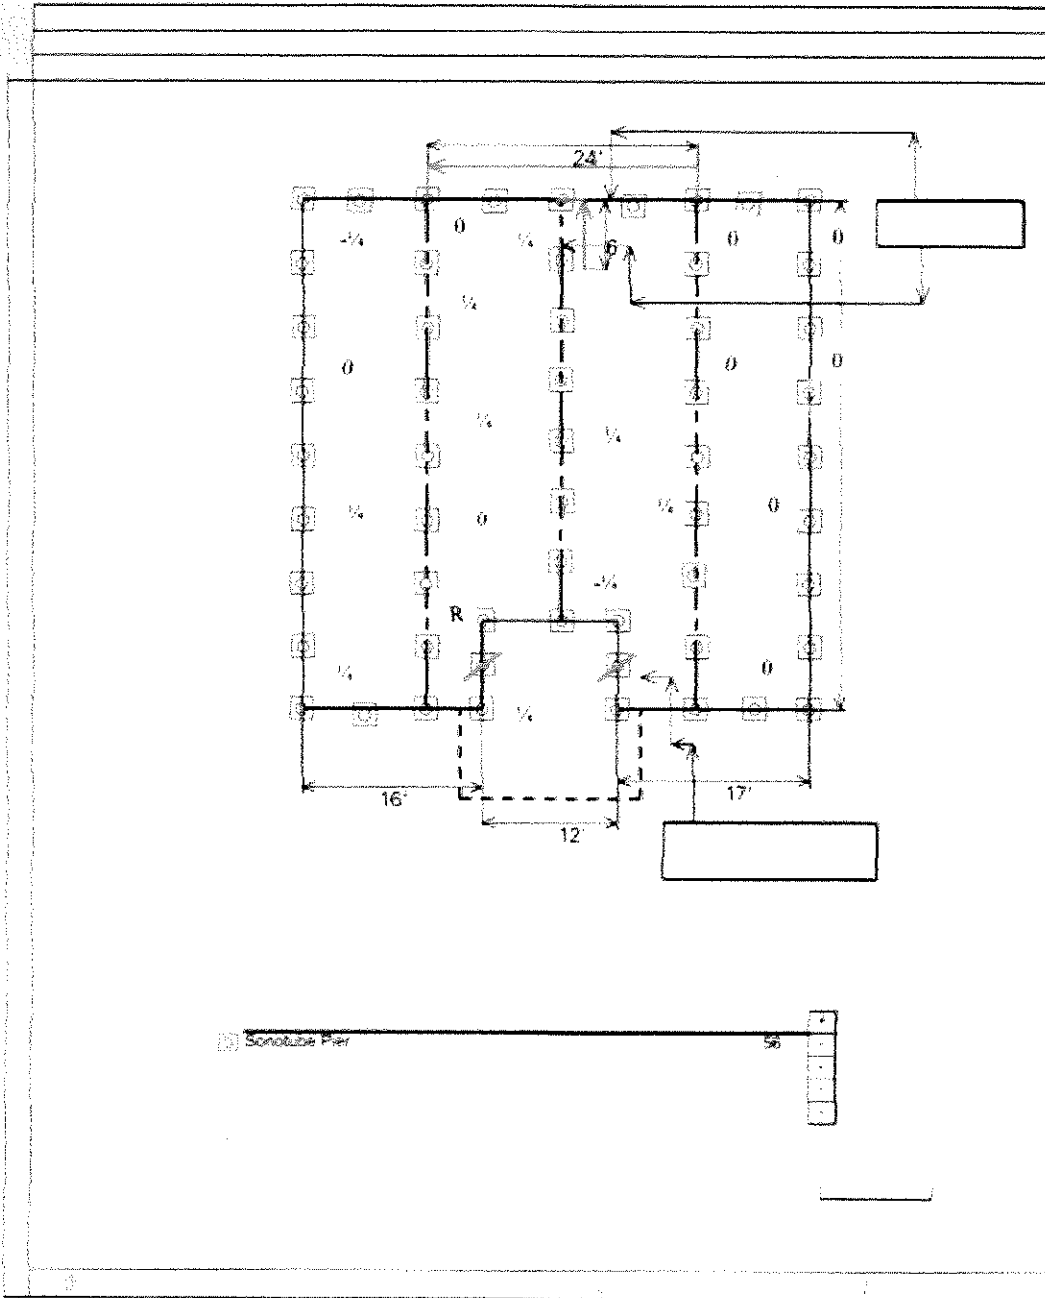
REF "A"

The floor area of the structure was raised to within 1/4-inch level position. The contractor stated they would complete backfilling and clean up the work area.

x/x -FINAL FLOOR ELEVATIONS (09/26/19)
